Restoration of Episkopi,
Sikinos

photo January 2022, after the implementation of the restoration

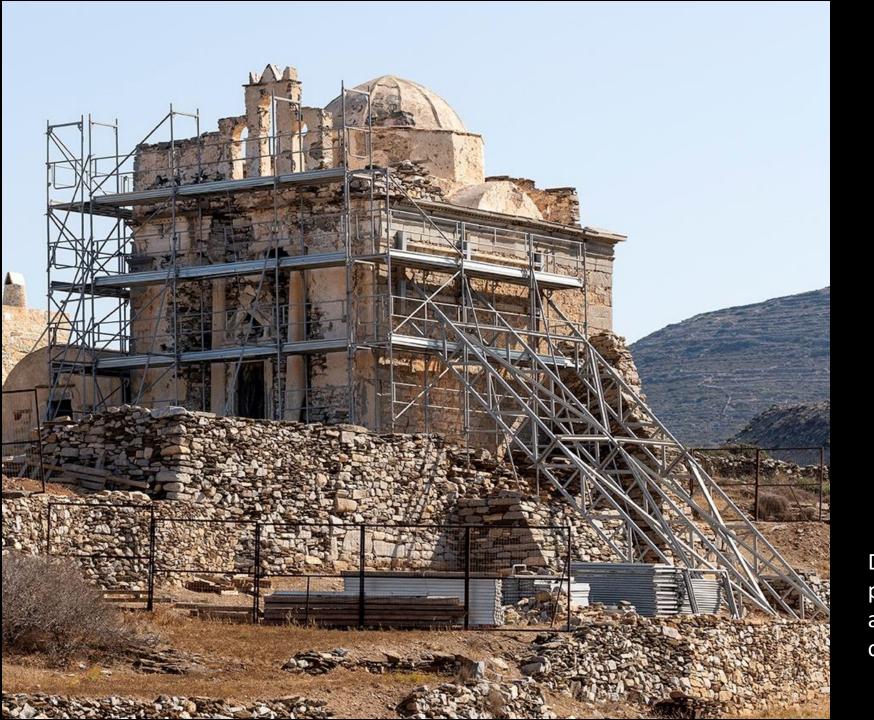
During the restoration project – exterior scaffolding and metal supporting of the outward inclined south wall

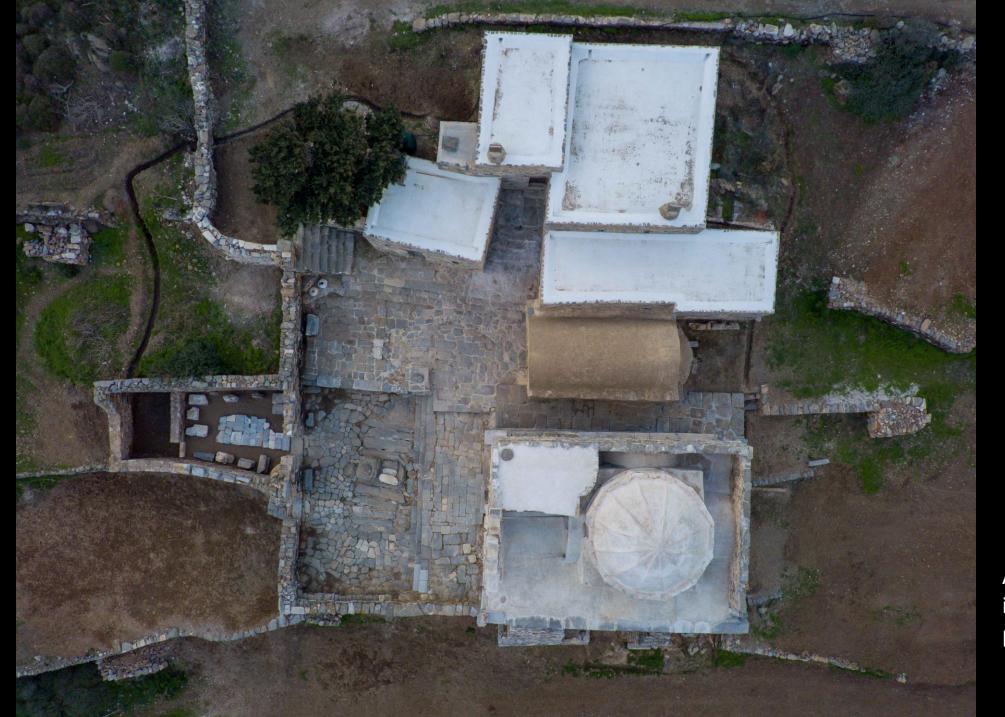
Aerial photo after the implementation of the project

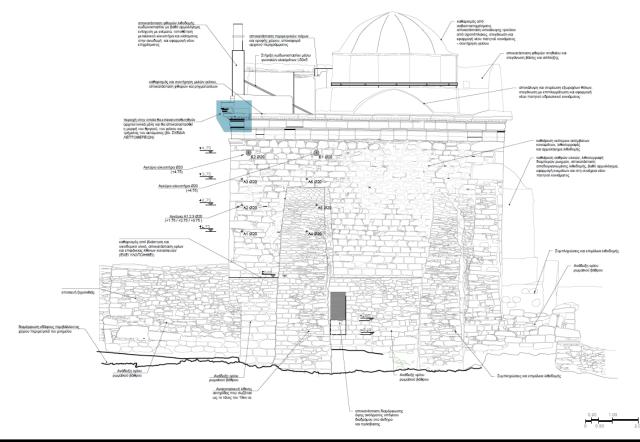
South Façade - documentation drawing

- proposal

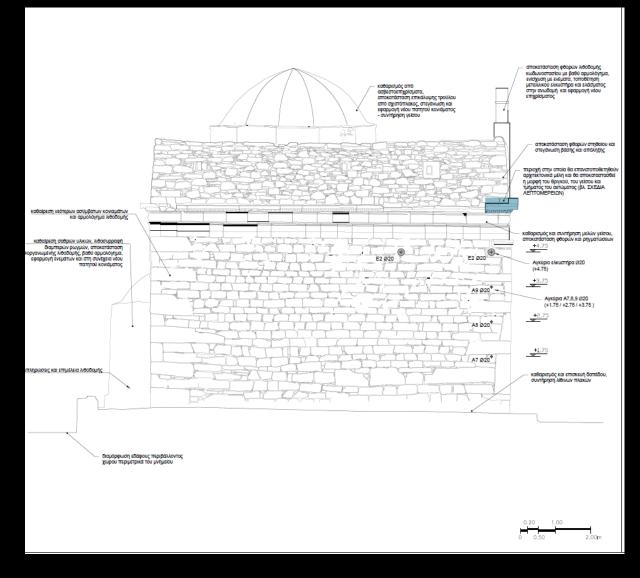
North Façade - documentation drawing

- proposal

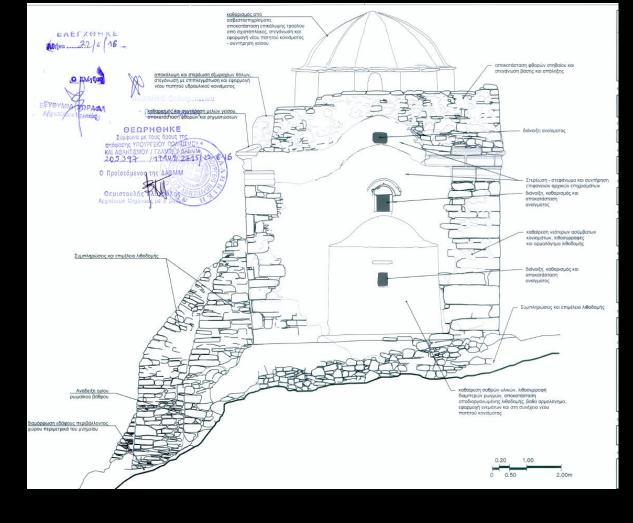
East Façade - documentation drawing

- proposal

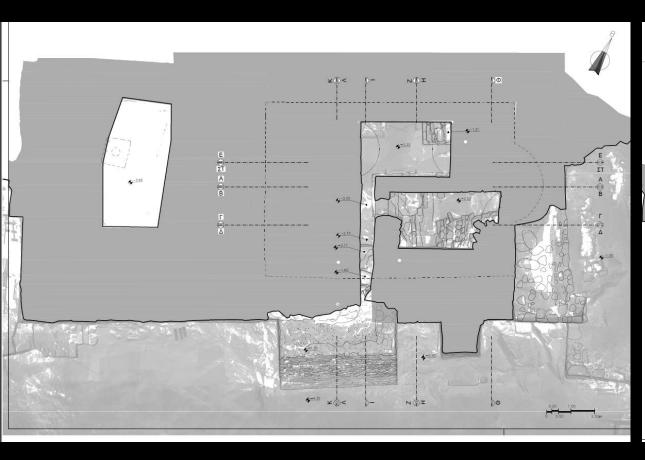
Underground vaulted crypts - documentation plan

- proposal

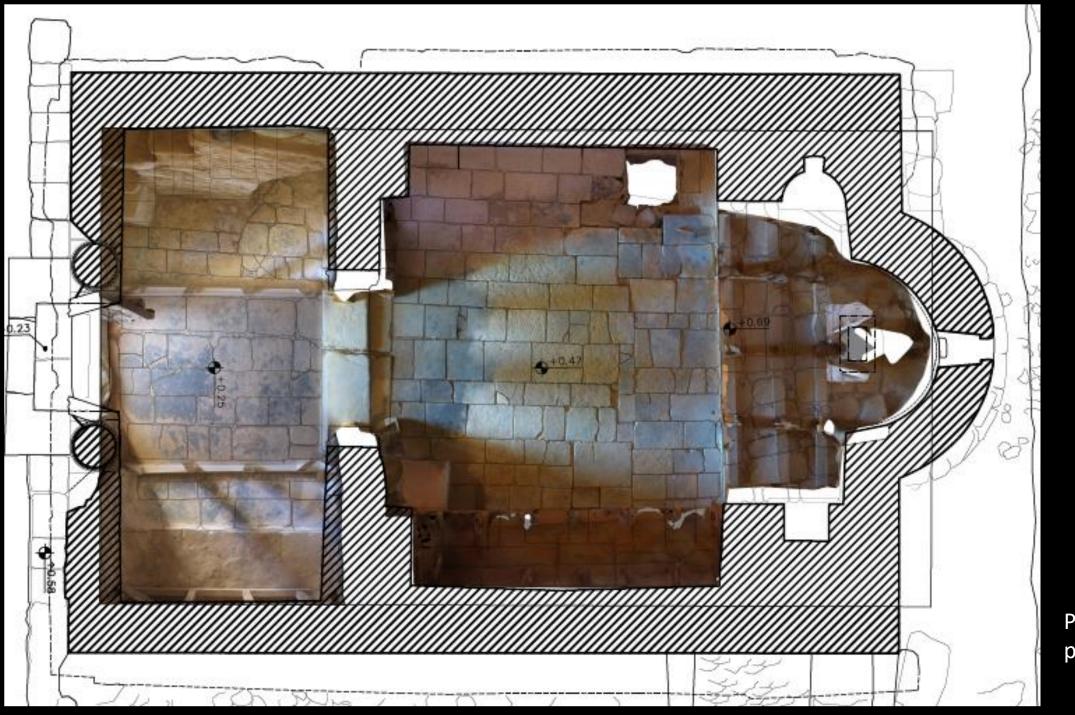
Plan of the roman pavement - before

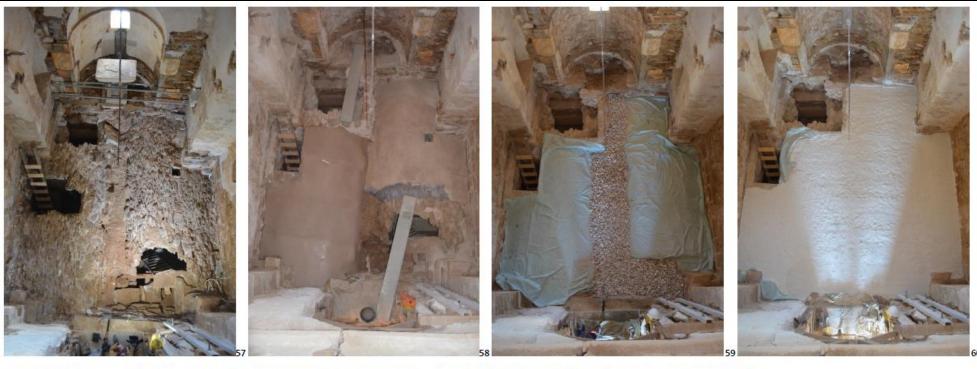
# Consolidation measures - strengthening the vaults of the crypts

εικ. 57-60: Στερεώσεις και συμπληρώσεις στα εξωρράχια των θόλων του υπογείου -αρμολόγημα, επίχρισμα, πλήρωση με σκύρα μέχρι την στάθμη της υπόβασης του δαπέδου

εικ.61-63: Λεπτομέρειες από τις στερεωτικές εργασίες στα εξωρράχια των θόλων

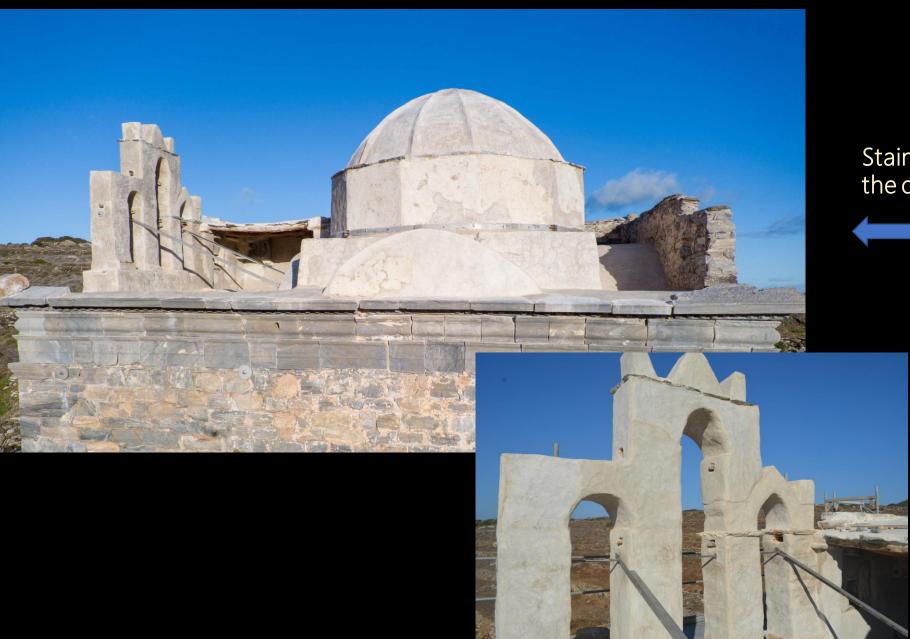
Stainless steel tie-rod hopping the dome

Stainless steel struts to support the belfry

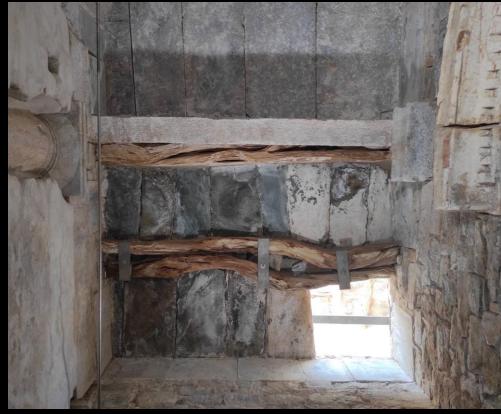
Supporting the wooden beam with a stainless steel construction

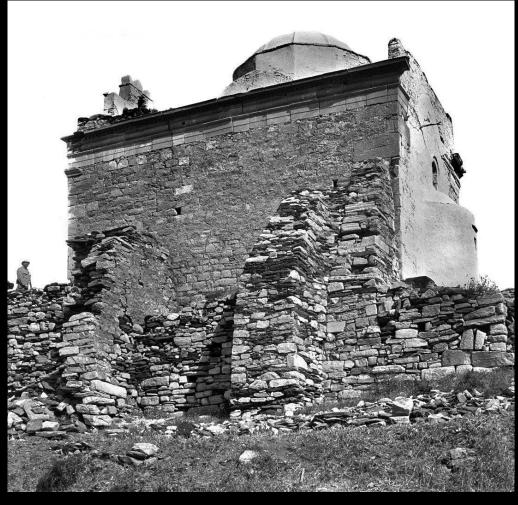
Rebuilding the medieval west buttress
